LAND REHABILITATION & EROSION CONTROL PROGRAM

The Ramu Nickel Project is situated in the Kurumbukari Plateau which has several down stream drainage systems that eventually drains to the main Ramu River system. Soil erosion is one of the major environmental criticisms and the Ramu floodplains including Banap Oxbow and Nape Swamp are very sensitive areas of concern during the mining operation.

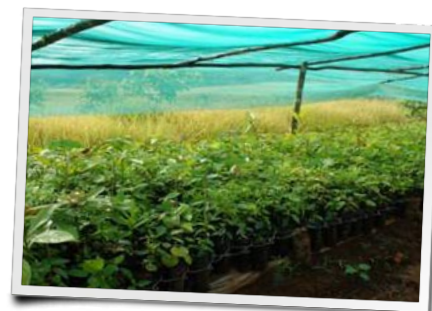
Figure 1 Seedlings growing in 50% shade standout bed.

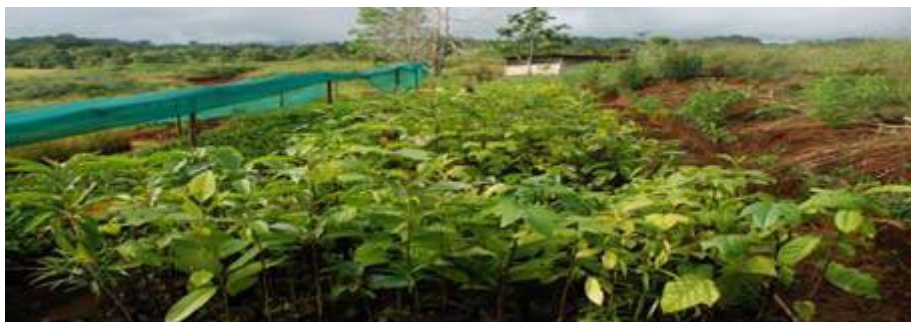
Figure 2 Mixed tree seedlings in an open (100% sunlight) stand-out bed

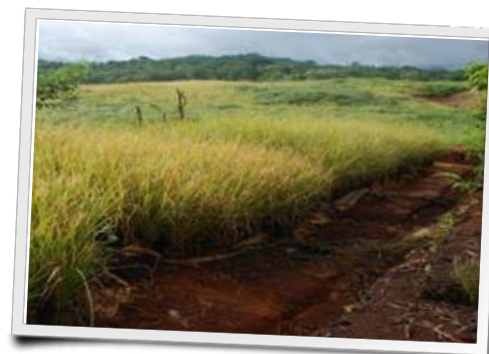
Figure 3 Vetiver (*Vetiveria zizanioides*) in open stand-out bed ready for planting.

Vetiver is a dense, clumping perennial grass, to 1.5 m in height, native in India and Ceylon. The grass is highly recommended for soil erosion control because it is non-seed producing variety specially selected not to become weedy and can grow well in all environmental conditions. Vetiver roots cover 20-30 mm of soil and compact the soil firmly.

Their hedges are found to be very effective in soil and moisture conservation. The stiff stems of the thick hedge slow the movement of runoff water and spread it out, trapping silt behind the hedge. This allows more water to be absorbed into the soil, thus reducing runoff and erosion. Vetiver is non-invasive, has no runners or rhizomes, and only spreads by tillering.

Therefore, Vetiver will mainly be used for steep slope stabilization and rehabilitation of degraded and disturbed land.
